REPORT NO. 8-60-50G-III

MONTHLY PROGRESS REPORT

ENGINEERING PROGRAM FOR
THE PILOT PRODUCTION OF A
LIGHTWEIGHT ANTITANK WEAPON

MONTH OF AUGUST 1960

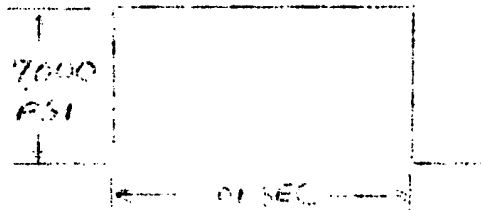
The motor design calls for an operating pressure of approximately 6000 psi for a time duration of .010 seconds. As we know, the actual performance of the motor does not quite correspond to these design criteria. If the above statement were completely fulfilled in the present motor, the time vs. pressure curve obtained from this motor would be a square wave as follows:

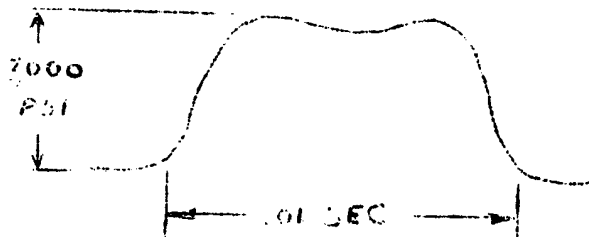
As previously discussed, this ideal situation is not adhered to in this case. In fact, it is almost impossible to have any rocket motor produce a perfect square wave. A typical time-pressure curve of a standard rocket motor might well look like this:

As can be seen, the rise and drop are not vertical and the pressure plateau is not perfectly horizontal.

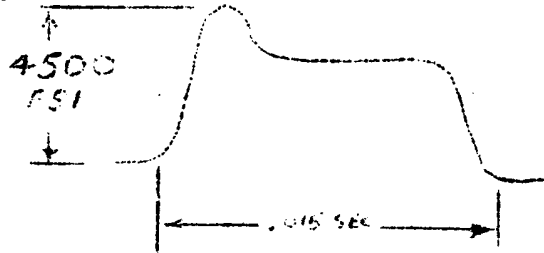
Due to considerations of security, which made it necessary to "sterilize" the design of this particular motor, the typical time-pressure curve obtained from it may vary from a curve obtained at the hot temperature with this shape:

The peak formed at the beginning of the burning time is more pronounced at the cold temperature.

This sudden loading and unloading creates a stress condition on the vessel containing the pressure which is very difficult to evaluate fully. The sudden unloading after a very short duration of the peak pressure may set up stresses caused by oscillation far in excess of anything created by the nominal value of the peak pressure. In addition to this consideration it is possible that since the peak rises so suddenly the curve in some one rocket may keep on going up higher than average, thus creating an excessive peak pressure.

It may therefore be possible to assure safety for this lot of motors by changing to steel barriers. However, it is felt that if the sterility requirements could be changed in such a manner as to permit the use of propellant more nearly of a standard size, an improved motor could be designed which would not imply the hazard of the peak in the time-pressure curve. Such a motor would, in addition, have the great advantage of making use of more readily producible propellant, which would decrease the cost of each round very substantially. This is meant as a suggestion for future improvement and cost reduction.
